# Implement Of Cost Effective Method And Increasing Warranty Period Of Single Cylinder Engine

**Abstract**— This paper describes the failure found at value guides on single cylinder forced splashing lubrication system 4 stroke engine. We are found that problem and designing the valve for this engine. Also our project maximizes the engine duration period, life and reduces the huge emissions, high fuel consumption and high engine noise. We are analyzed engine break down report and failure crankcase model. Also this project reduces the cost of values and increasing warranty duration of engine. We have shown the crankcase side view, root cause for problem, valve guide failure: possible causes, contribution to engine cost, crankcase assembly with valve guide, valve guide seating arrangement technique, valve nomenclature, and implementation of solution for this engine.

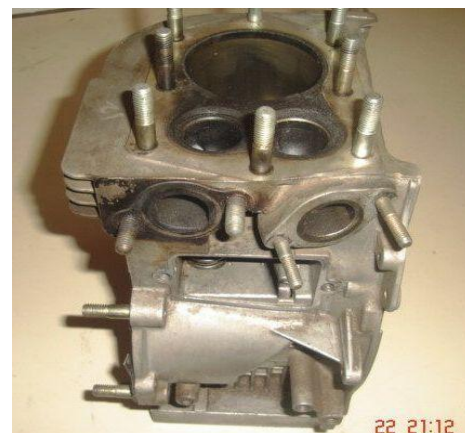
## VI. CRANKCASE SIDE VIEW

Figure 1, it shows a side view of crankcase.

Crank case is cast integral with the cylinder block made of Aluminum alloys. It supports crankshaft and camshaft with the help of bearings. Crank case takes the high cost efficient part in the engine

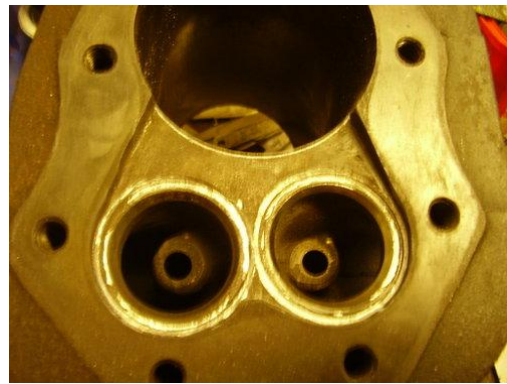
Figure 2

### A. Engine Top View

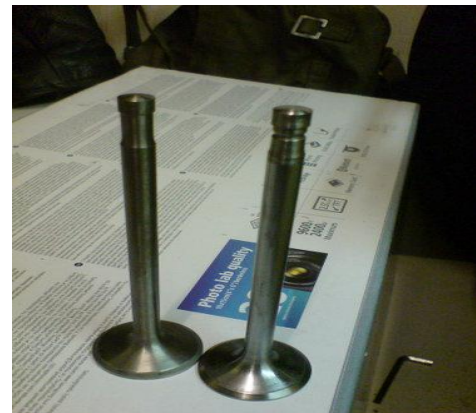
Figure 3, it shows a valve figure.

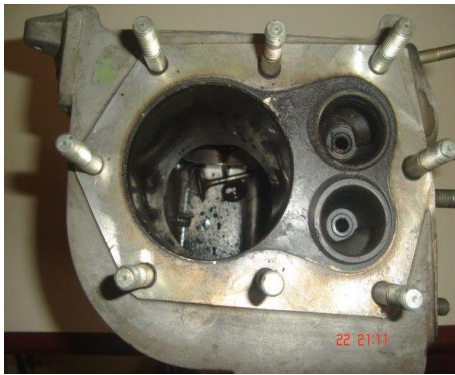
Figure 4

Valve guide wear is the root cause for the crankcase warranty failure problem, due to longer burn times. The primary symptom of valve failure is loss of compression. When the wear absorbed, crank case must be replaced, which is totally high cost reduction.

This is the failure model of the crank case assembly. In the past days the crank case is to be replaced fully, now both the valve guides replacement is enough. By this criteria, the cost will be saved.

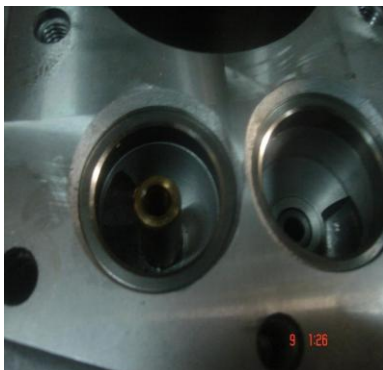
### A. VALVE GUIDE PULLED

Figure 5, shows a valve pulled in position.

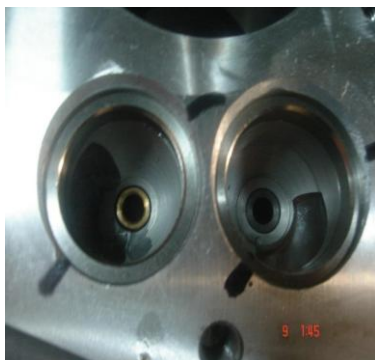
### B. VALVE GUIDE IN POSITION

Figure 6, shows the positioning a valve.

Remove the cylinder head from the vehicle to a safe working area & clean the parts. Both the valves are shrink in Liquid Nitrogen at Sub-Zero degree temperature, which provide leak proof. Insert the valve into the guide, allowing the valve to remain off of its seat.

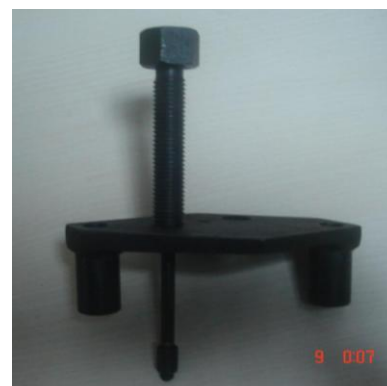
### A. VALVE GUIDE PULLER

Figure 8, shows a puller of valve guide.

The puller for the Valve Guide was produced with the help of production Engineering department
